ANNUAL REPORT FOR 2015

UT to Middle Fork Creek Site B Mitigation Site
Madison County
TIP No. R-2518A
COE Action ID: SAW-2007-2197-357/300
DWR #: 20071134

Prepared By:
Natural Environment Section & Roadside Environmental Unit
North Carolina Department of Transportation
November 2015

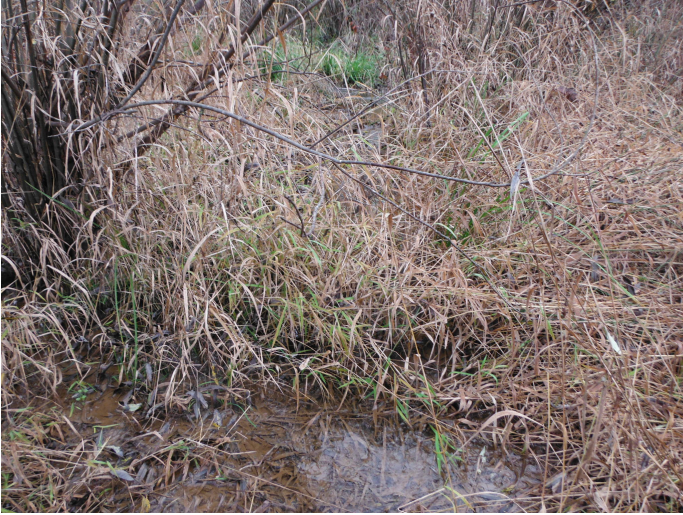
Photo Point #1 (Upstream)

The UT to Middle Fork Creek Site B Mitigation Site has met the required monitoring protocols for the sixth formal year of monitoring on the stream and the fourth formal year of monitoring on the planted vegetation. The channel throughout the stream restoration site is stable and the planted vegetation is surviving at this time.
